PRIMARY RECORD

* Resource Name or #: 2437 Dulzura Avenue, APN 539-042-04

BUILDING, STRUCTURE, AND OBJECT RECORD

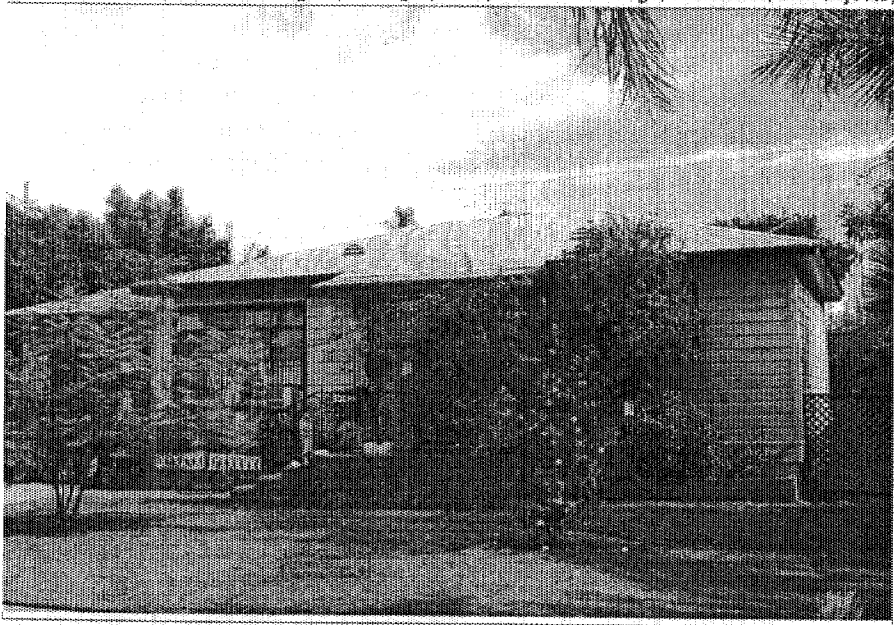
Photo Number: P0003086.JPG Est. Date: 2001

This house was built in 1951 in the Ranch style. It is a one story house with a hipped roof and eyebrow vents. The exterior wall material is clapboard siding. The garage door on the attached single car garage has been removed and replaced with industrial metal sash windows (either an early addition or done as a bonus room). Windows are consistent in design. The porch has an attached low-pitch shed roof supported by wrought iron. Entryway is raised with brick steps and wrought iron railing. The house is an example of a different architectural style (Ranch) that fits with the pre-established scale, character, and articulation of the neighborhood and historical context. The house is located in the community of Burlingame. It is in good condition. The total usable floor area is 1,424 square feet. The house features 4 bedrooms and 1 bath. The total lot area is 6,300 square feet.

Although this house was identified by Assessor Information as built in 1951, it maintains many of the Craftsman features of an earlier structure. The building is within the Burlingame Historic District.

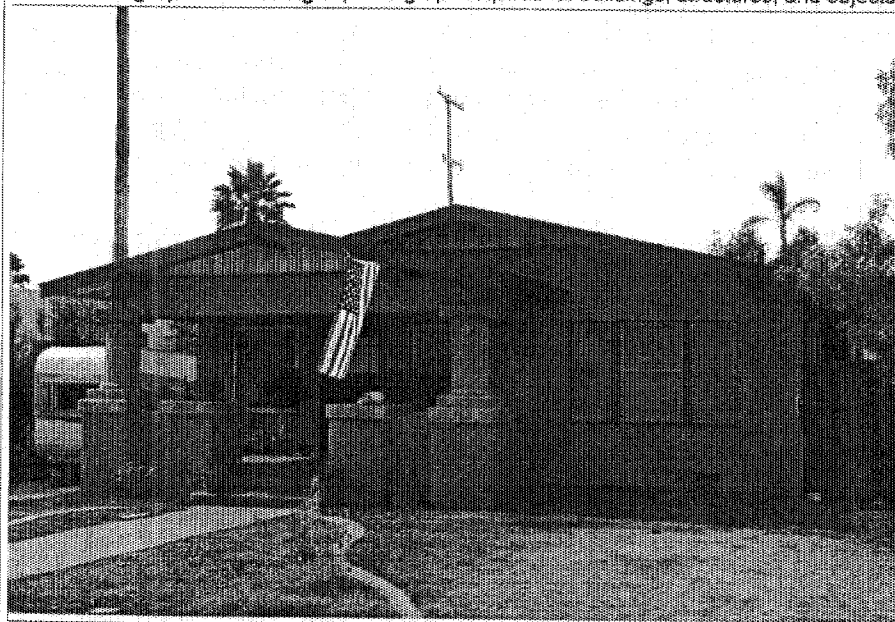
Photo Number: P0003078.JPG Est. Date: 2001

* P3a. Description: (Describe resource and its major elements. Include design, materials, condition, alterations, size, setting, and boundaries.)
This house was built in 1922 in the Craftsman Bungalow style. The house is one story with a low-pitch gable roof and vertical vents. The exterior wall material is textured stucco, and is not consistent with the original fabric of the house. The porch is supported by thick stucco columns on large stucco piers. The door is centered in the porch with multi-lights. All windows appear to be original double-hung Craftsmen style windows. The house is located in the community of Burlingame. It is in good condition. The total usable floor area is 1,515 square feet. The house features 3 bedrooms and 1 bath. The total lot area is 6,100 square feet. Other improvements on the property include a single-car detached garage in the same style as the house.

Related features on the property include a detached garage. The building is within the Burlingame Historic District.

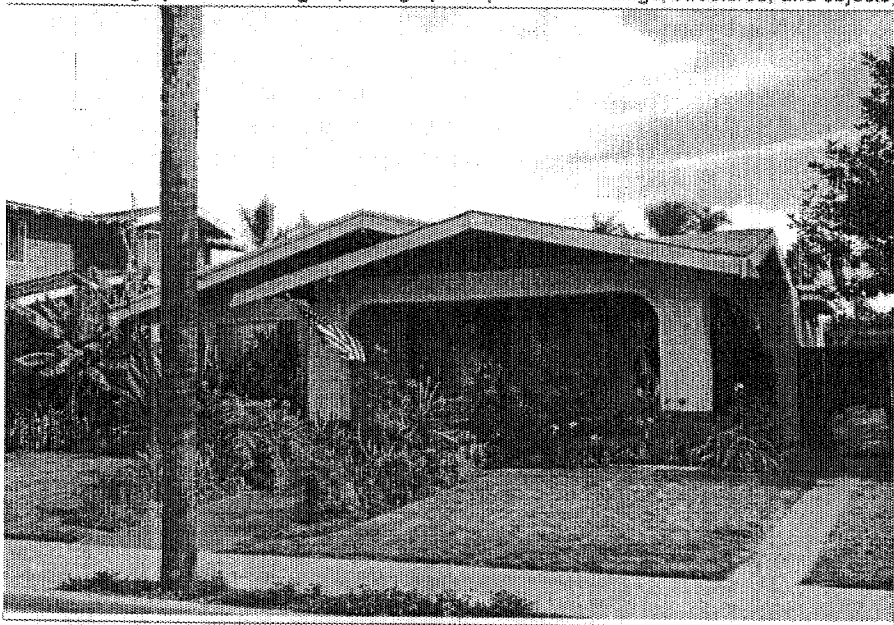
Photo Number: P0003088.JPG Est. Date: 2001

This house was built in 1949 in the Craftsman Bungalow style. It is one story with a low pitch gable roof. The exterior wall surface is textured stucco. The house features an off-centered front gable porch supported by square pillars. The porch entryway is slightly curved at the corners, forming an elongated segmental arch. The front door is sliding glass with full length side lights. The window on the left side has been modified with aluminum. The walkway to the house is scored concrete and landscaped along the sides. The house is located in the community of Burlingame. It is in fair condition. The total usable floor area is 1,796 square feet. The house features 3 bedrooms and 2 baths. The total lot area is 6,300 square feet.

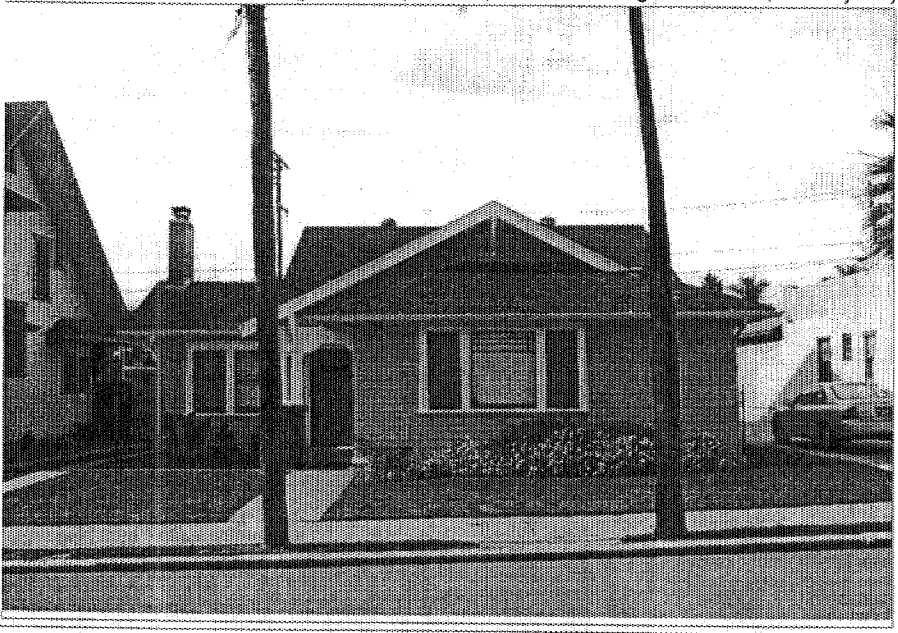
Photo Number: P0003076.JPG Est. Date: 2001

* P3a. Description: (Describe resource and its major elements. Include design, materials, condition, alterations, size, setting, and boundaries.)
This house was built in 1943 in the Craftsman Bungalow style. The house is one and one-half stories with a composite shingle roof and a high-pitch cross-gable roof held by wood knee braces. The front porch is enclosed and surrounded by a shed roof. The enclosure appears to be an early alteration and uses materials consistent with the original house fabric. Clapboard siding and Craftsman style sectional windows form the main entry. A section of the original porch remains as an entry with a brick face and double tapered wood piers that support the roof. All windows are original wood Craftsman style double-hung windows with upper multi-lights. The rear garage is a later addition that fits with the scale and character of the main house. The house is located in the community of Burlingame. It is in good condition. The total usable floor area is 1,610 square feet. The house features 4 bedrooms and 2 baths. The total lot area is 5,200 square feet.

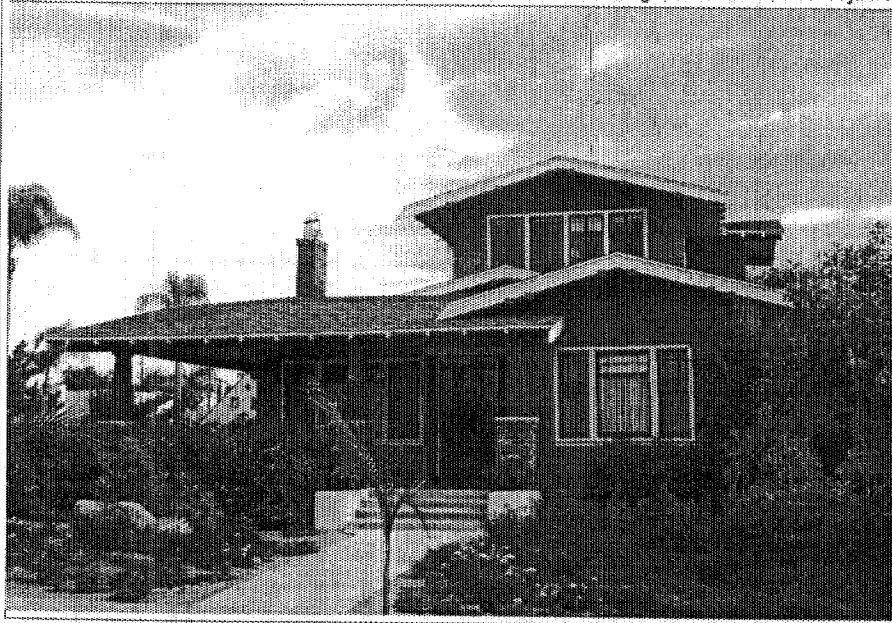
Photo Number: P0003089.JPG Est. Date: 2001

* P3a. Description: (Describe resource and its major elements. Include design, materials, condition, alterations, size, setting, and boundaries.)
This house was built in 1912 in the Craftsman style. The house is two stories with multiple cross-gable roofs and pointed rafters on the first and second stories. The exterior wall material is alternating square and rectangular wood shingles. The main façade wrap-around porch is supported by brick piers under square wood columns with simple capitols. The main entry features a non-contributing, decorative wooden door with an oval glass pane flanked by pilasters. The windows have multi-lights on top and are flanked by double-hung windows which also have multi-lights. The house is located in the community of Burlingame. It is in good condition. The total usable floor area is 2,219 square feet. The house features 4 bedrooms and 2 baths. The total lot area is 6,500 square feet.

According to Don Covington's book, "Burlingame, The Tract of Character", "This large, rambling Craftsman style house was built on land owned by McFadden 7 Buxton who sold the house and lot to Howard Hikes in October 1912 at completion of the construction. Hikes lived in the house for the first year, and sold it in 1914 to realtor James Going for \$8,500. Although Howard Hikes is the registered builder for the property, William Wheeler may have been its designer".
